## Understanding interfaces within a railway environment.

Presented by: Nathan Darroch, MA, MIAM;

as part of the MSc in Transport Engineering and Asset Management, Railway Asset Management module.

8 February 2018.

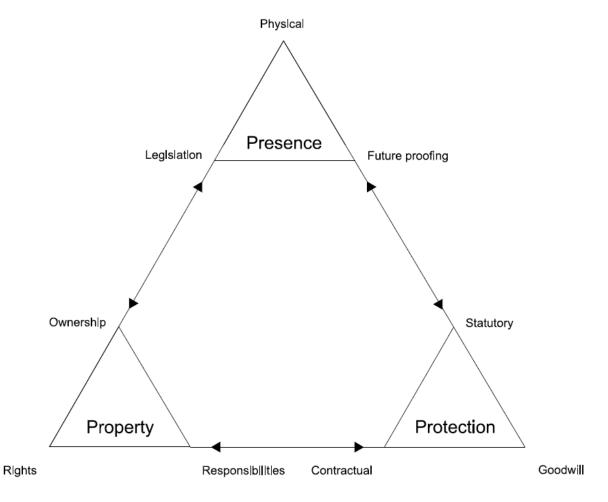
To understand the railway; its environment; and how these relate to one another, we therefore need to understand the interfaces involved.

Source: Darroch, N., Beecroft, M., & Nelson, J., 2016.

Every example here consists of interfaces between the railway and its environment. All are different, but all have the same principles of presence, property, and protection.

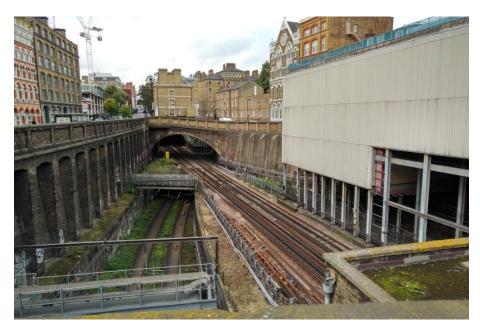
#### Scenario 1: Presence

Ray Street pre-existed the railways.

The Metropolitan railway opened in 1863.

The widened line was completed in 1867.

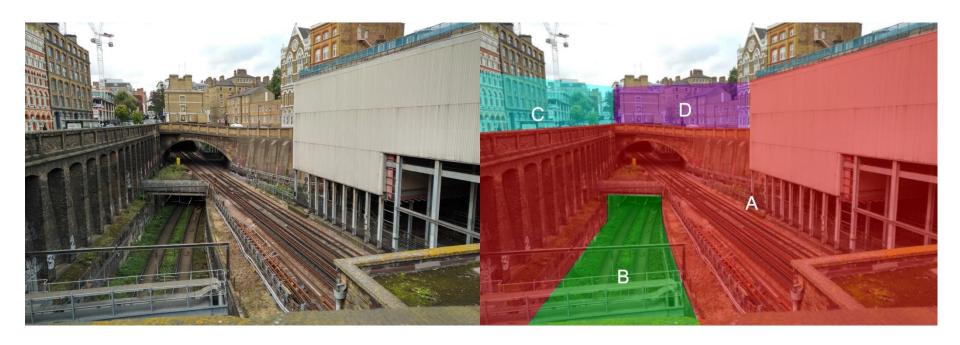
#### Scenario 1: Property

A = London Underground land and airspace

B = Network Rail land and airspace

C = TfL Streets highway

D = Local authority highway

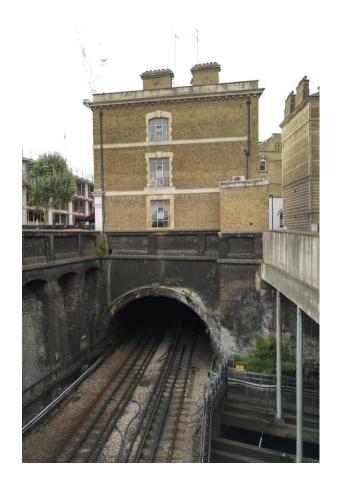
#### Scenario 2: Presence

The Metropolitan railway opened in 1863.

The widened line was completed in 1867.

The building was erected c.mid 1870s, post railway construction.

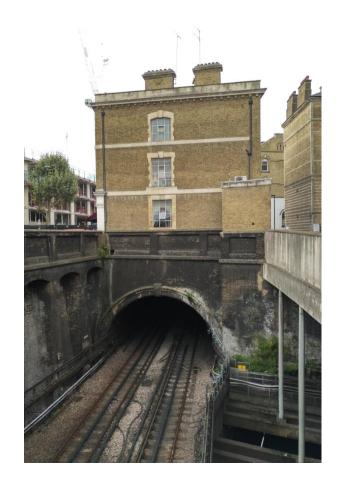
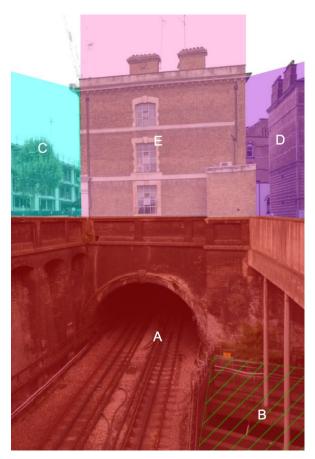
#### Scenario 2: Property

A = London Underground land and airspace

B = Network Rail land and airspace (below)

C = TfL Streets highway

D = Local authority highway

E = Building owner

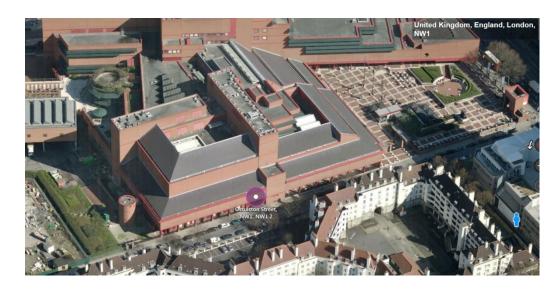
#### Scenario 3: Presence - a

The current British Library was built in the 1990s.

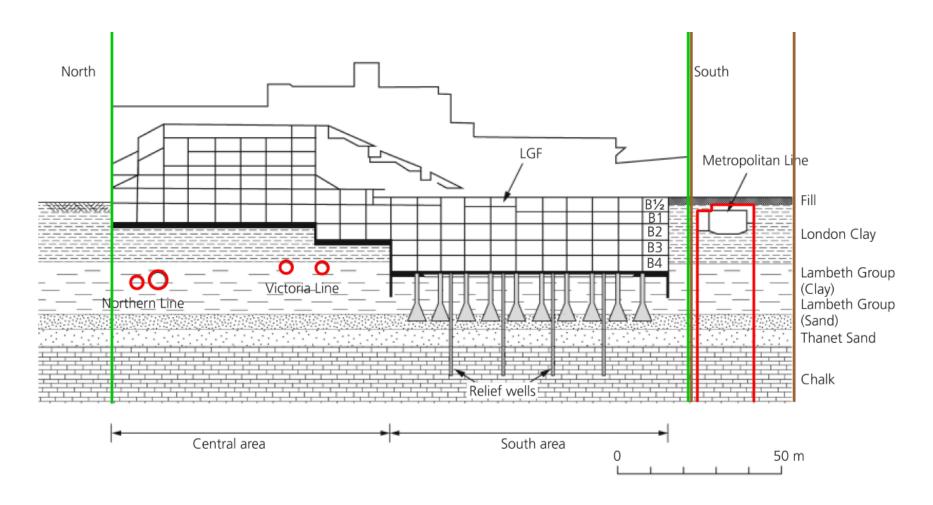
#### Scenario 3: The effect of Presence, Property, and Protection interfaces

Source: Simpson, B., and Vardanega, P., 2014.

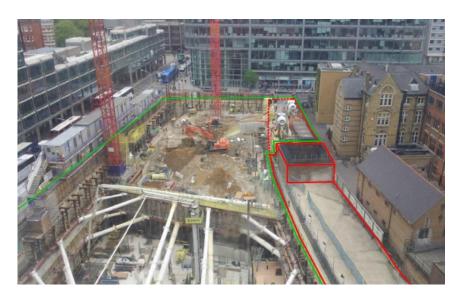
#### Scenario 4: Protection

Located on Victoria Street, Westminster

directly adjacent to the District and Circle lines

the original building was demolished and excavation undertaken to create basement levels.

Once this was completed, new buildings were erected.

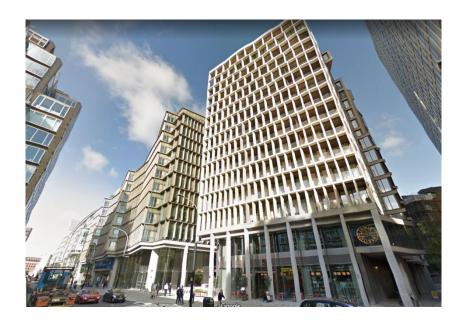
#### Scenario 4: Protection

The new development is:

- 8 storeys below ground level, at its lowest point
- up to 14 storeys above ground level
- 22 storeys in total

directly adjacent to an underground railway.

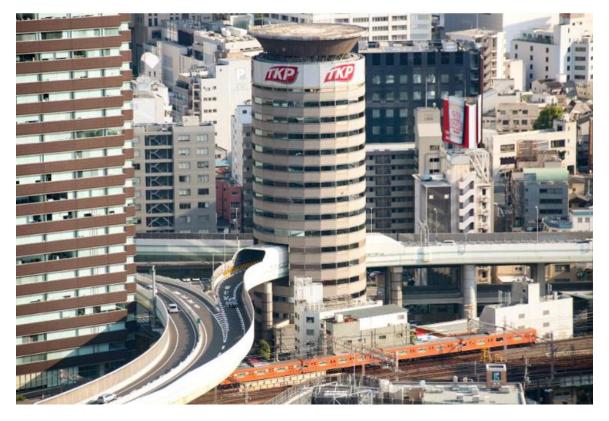
In Osaka, Japan, there is a highway that goes *through* a building.
